## Annual Inspection

Mid Suffolk District Council

Redgrave

Old Playing Fields Half Moon Lane, Redgrave , Suffolk,  
IP22 1RL

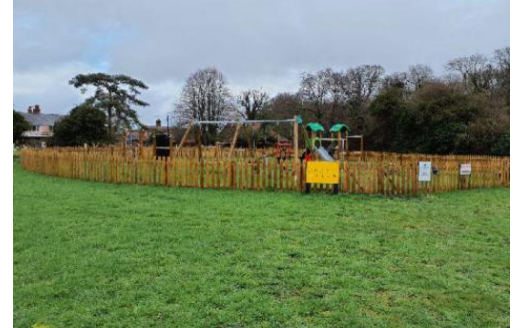
**Item:** Site General  
**Manufacturer:** Owner/Operator  
**Surface Type:** N/A  
**Item Quantity:** 1  
**Equipment Compliance:** N/A  
**Surface Area Compliance:** N/A

There is standing water in the area - Monitor and consider providing drainage if required

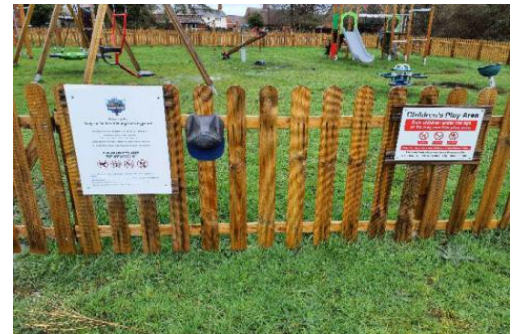
**Item:** Sign  
**Manufacturer:** Not Identified  
**Surface Type:** N/A  
**Item Quantity:** 1  
**Equipment Compliance:** N/A  
**Surface Area Compliance:** N/A

BS EN 1176 Part 7 recommends that signage shall include the site name / address - Provide additional information

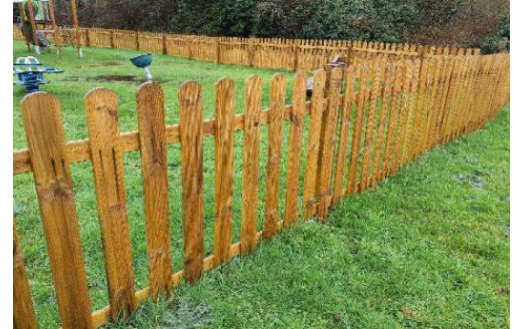
**Item:** Fencing - Timber  
**Manufacturer:** Not Identified  
**Surface Type:** Grass  
**Item Quantity:** 1  
**Equipment Compliance:** N/A  
**Surface Area Compliance:** N/A

There are a number of timber slats missing from the fence - Replace missing slats

There are a number of fixings missing from the fence - Replace missing fixings

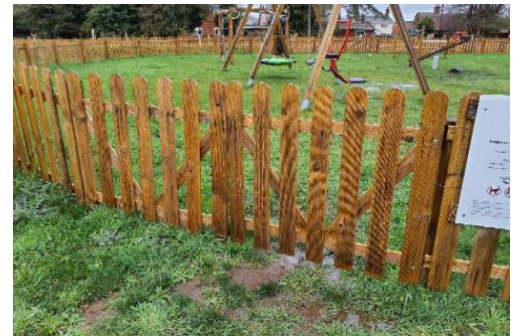
**Item:** Gate - Combination  
**Manufacturer:** Not Identified  
**Surface Type:** Grass  
**Item Quantity:** 1  
**Equipment Compliance:** N/A  
**Surface Area Compliance:** N/A

There is no padlock on the maintenance gate - Provide a padlock to secure the gate

There are openings that are less than 12mm that could trap or crush fingers - Provide a 12mm gap throughout full range of motion at both sides of gate

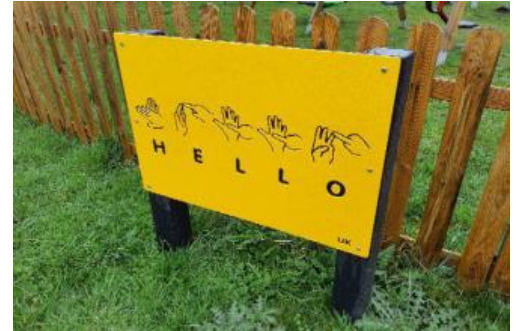
**Item:** Play Panel  
**Manufacturer:** Kompan Ltd  
**Surface Type:** Grass  
**Item Quantity:** 1  
**Equipment Compliance:** Yes  
**Surface Area Compliance:** N/A

This item is satisfactory - no work required -

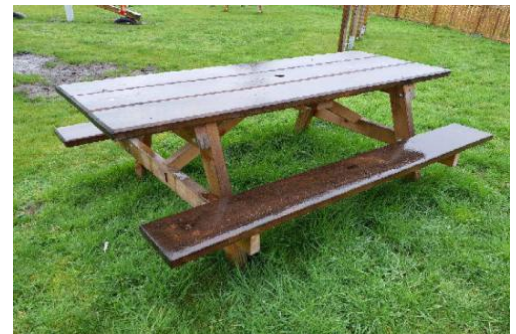
**Item:** Picnic Table  
**Manufacturer:** Not Identified  
**Surface Type:** Grass  
**Item Quantity:** 1  
**Equipment Compliance:** N/A  
**Surface Area Compliance:** N/A

The table/s is/are not secured to the ground and there is some potential for the item/s to be moved within falling spaces of equipment - Secure to the ground

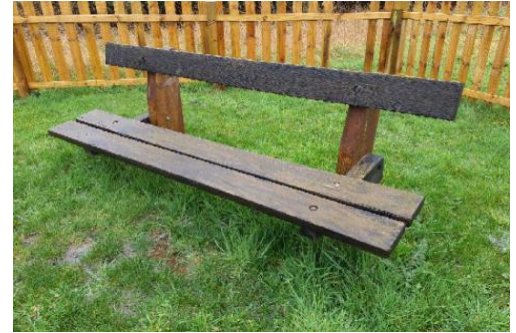
**Item:** Bench  
**Manufacturer:** Not Identified  
**Surface Type:** Grass  
**Item Quantity:** 1  
**Equipment Compliance:** N/A  
**Surface Area Compliance:** N/A

The seat slats are slanted downward - Adjust if required

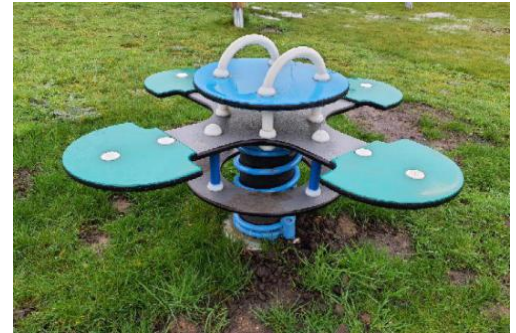
**Item:** Four Way Springer  
**Manufacturer:** Kompan Ltd  
**Surface Type:** Grass Matrix Tiles  
**Item Quantity:** 1  
**Equipment Compliance:** Yes  
**Surface Area Compliance:** Yes

The grass mats are silted up, the soil is compacted and the area will become very slippery when the soil is wet. - Reinststate as required

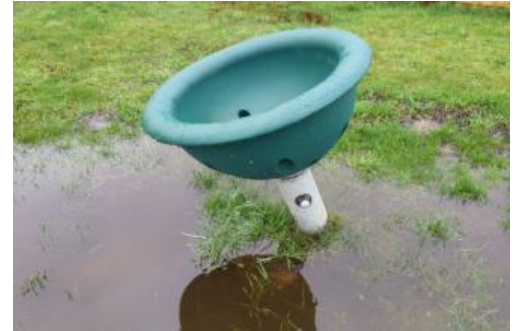
**Item:** Dish Roundabout  
**Manufacturer:** Kompan Ltd  
**Surface Type:** Grass Matrix Tiles  
**Item Quantity:** 1  
**Equipment Compliance:** Yes  
**Surface Area Compliance:** Yes

This item is satisfactory - no work required -

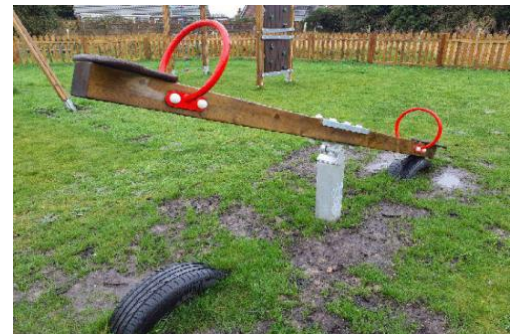
**Item:** See Saw  
**Manufacturer:** Kompan Ltd  
**Surface Type:** Grass Matrix Tiles  
**Item Quantity:** 1  
**Equipment Compliance:** Yes  
**Surface Area Compliance:** Yes

The grass mats are silted up, the soil is compacted and the area will become very slippery when the soil is wet. - Reinststate as required

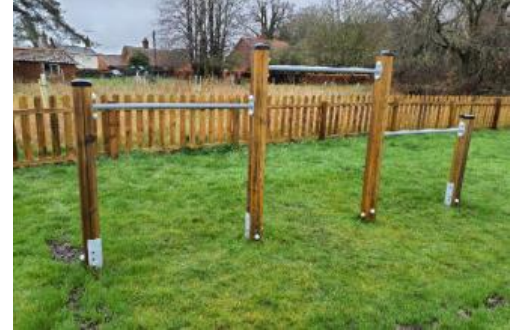
**Item:** Somersault Bars  
**Manufacturer:** Kompan Ltd  
**Surface Type:** Grass Matrix Tiles  
**Item Quantity:** 1  
**Equipment Compliance:** Yes  
**Surface Area Compliance:** Yes

This item is satisfactory - no work required -

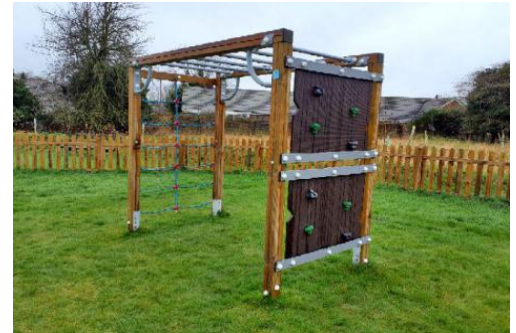
**Item:** Climbing Frame  
**Manufacturer:** Kompan Ltd  
**Surface Type:** Grass Matrix Tiles  
**Item Quantity:** 1  
**Equipment Compliance:** Yes  
**Surface Area Compliance:** No

The surfacing dimensions are short and do not meet with the requirements of the current applicable standard (1.94m required / 1.40m provided) - Extend surface area to comply

The surfacing dimensions are short and do not meet with the requirements of the current applicable standard (1.94m required / 1.70m provided) - Extend surface area to comply

The surfacing dimensions are short and do not meet with the requirements of the current applicable standard (1.94m required / 1.60m provided) - Extend surface area to comply

The surfacing dimensions are short and do not meet with the requirements of the current applicable standard (1.50m required / 1.94m provided) - Extend surface area to comply

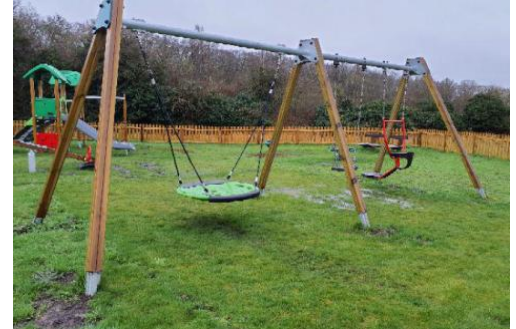
**Item:** 2 Bay Swing  
**Manufacturer:** Kompan Ltd  
**Surface Type:** Grass Matrix Tiles  
**Item Quantity:** 1  
**Equipment Compliance:** No  
**Surface Area Compliance:** Yes

The seat clearance from finished surface level to the underside of the seat is too low and does not meet the requirements of BS EN 1176 Part 2 (400mm minimum clearance required from rigid part of seat in most onerous position) - Adjust seat clearance

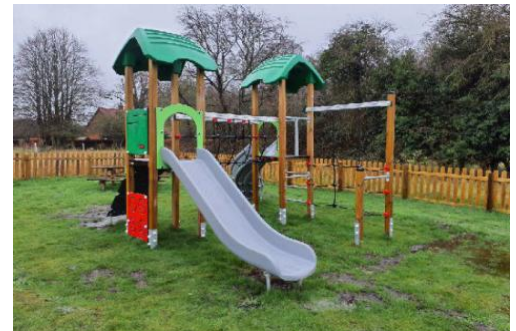
**Item:** Multi Play (Junior)  
**Manufacturer:** Kompan Ltd  
**Surface Type:** Grass Matrix Tiles  
**Item Quantity:** 1  
**Equipment Compliance:** Yes  
**Surface Area Compliance:** Yes

The grass mats are silted up, the soil is compacted and the area will become very slippery when the soil is wet. - Reinstate as required

There is/are bolt cap covers missing or damaged on the item - Replace missing or damaged bolt cap covers

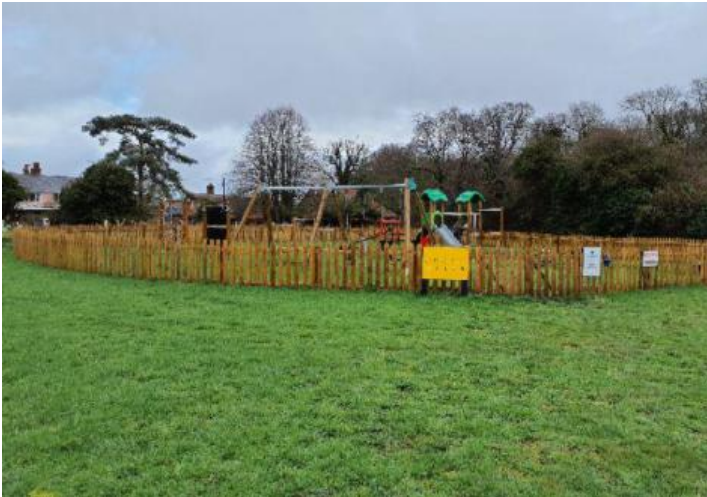
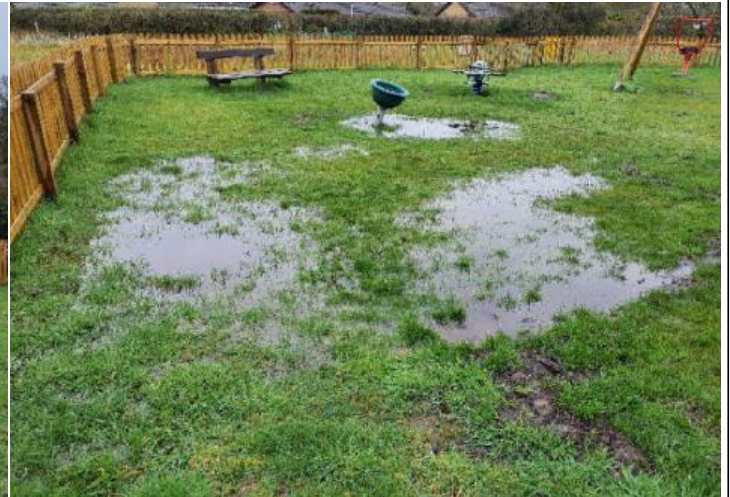
**Item:** Ancillary Items - Site General  
**Manufacturer:** Owner/Operator

**Finding:** There is standing water in the area

**Action:** Monitor and consider providing drainage if required

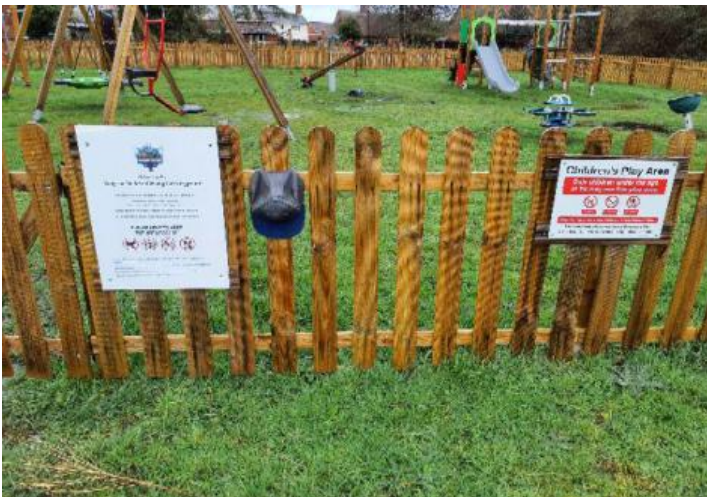
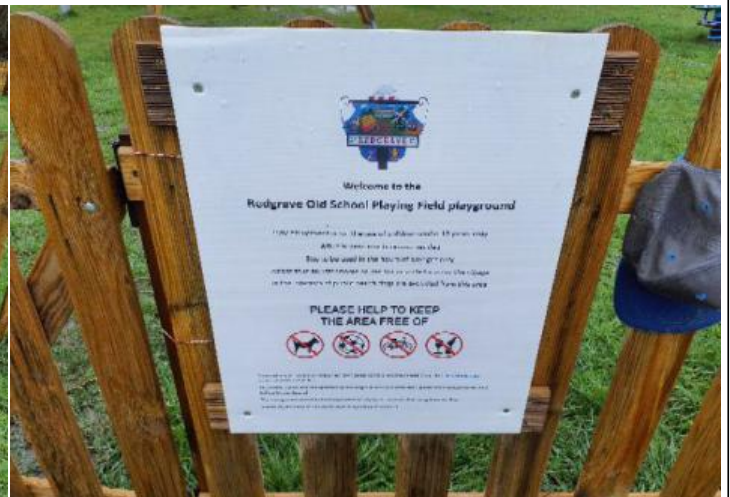
**Item:** Ancillary Items - Sign  
**Manufacturer:** Not Identified

**Finding:** BS EN 1176 Part 7 recommends that signage shall include the site name / address

**Action:** Provide additional information

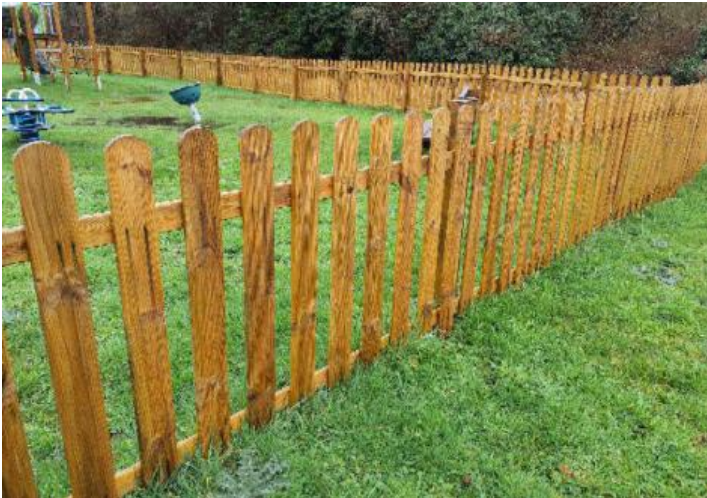
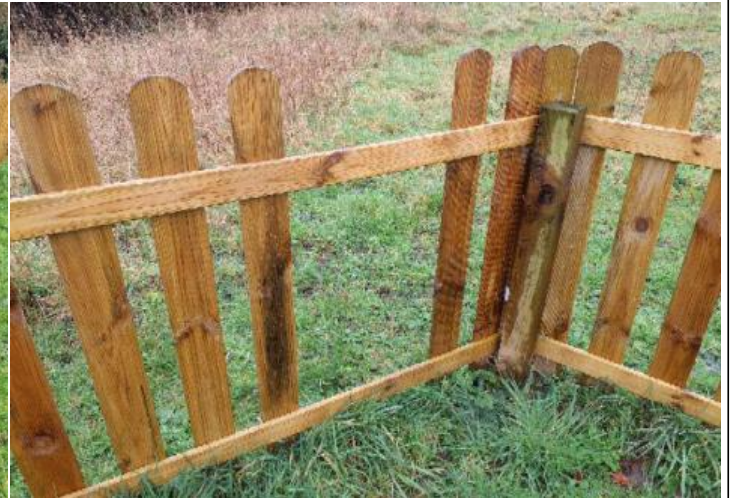
**Item:** Fences - Fencing - Timber  
**Manufacturer:** Not Identified

**Finding:** There are a number of timber slats missing from the fence

**Action:** Replace missing slats

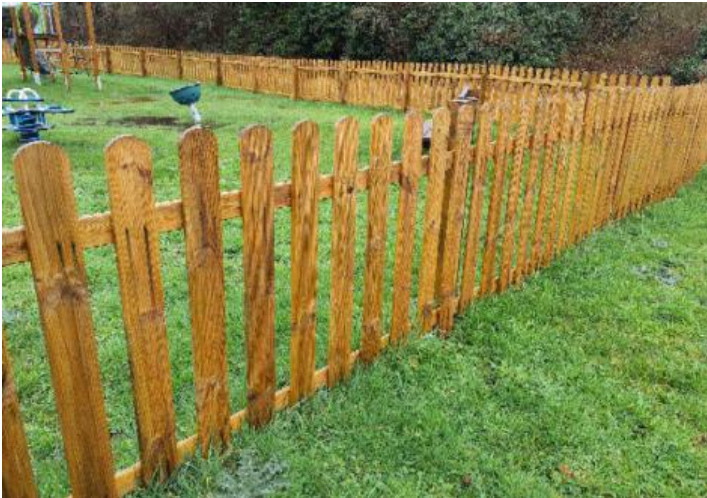
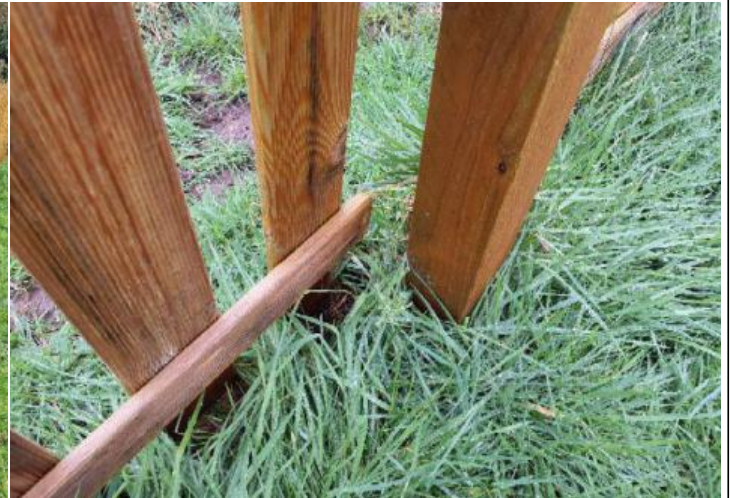
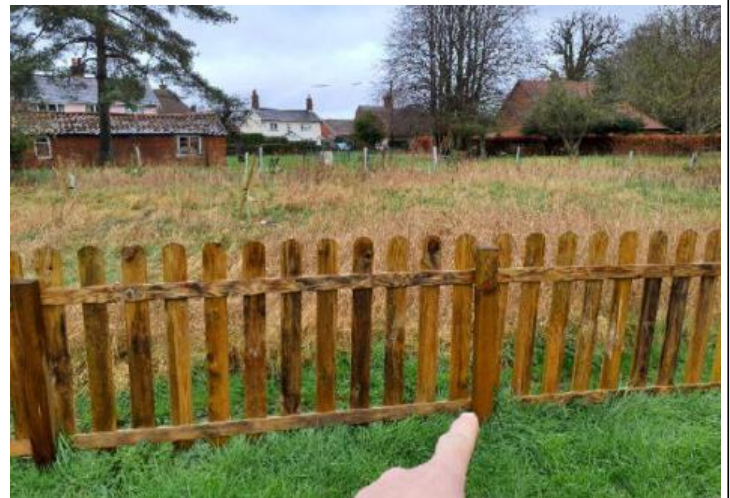
**Item:** Fences - Fencing - Timber  
**Manufacturer:** Not Identified

**Finding:** There are a number of fixings missing from the fence

**Action:** Replace missing fixings

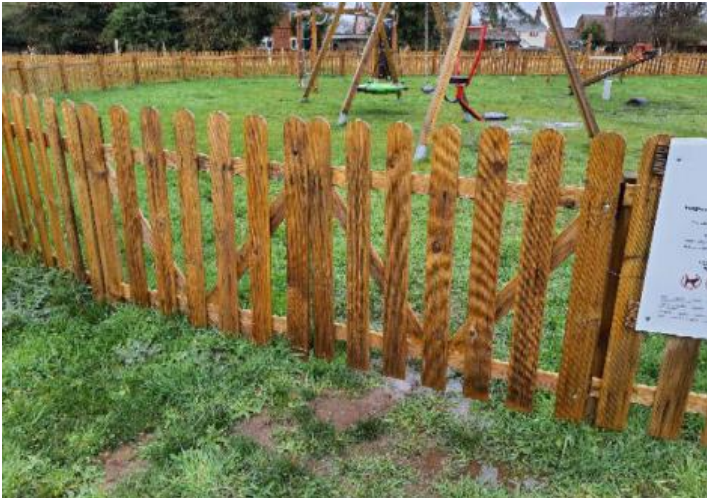
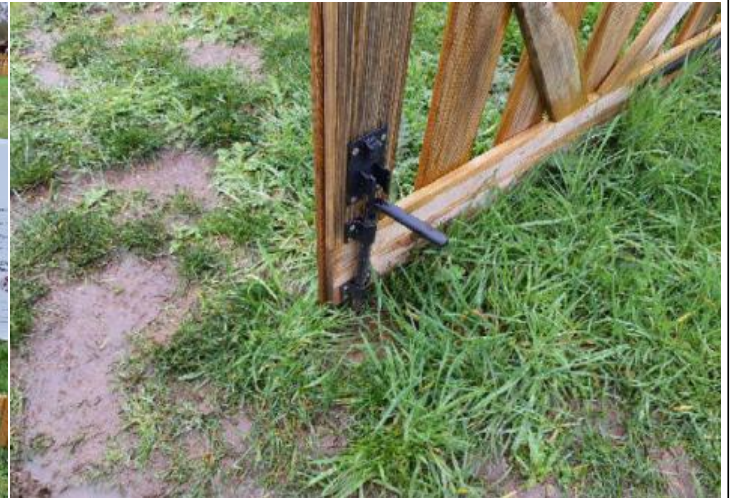
**Item:** Gates - Gate - Combination  
**Manufacturer:** Not Identified

**Finding:** There is no padlock on the maintenance gate

**Action:** Provide a padlock to secure the gate

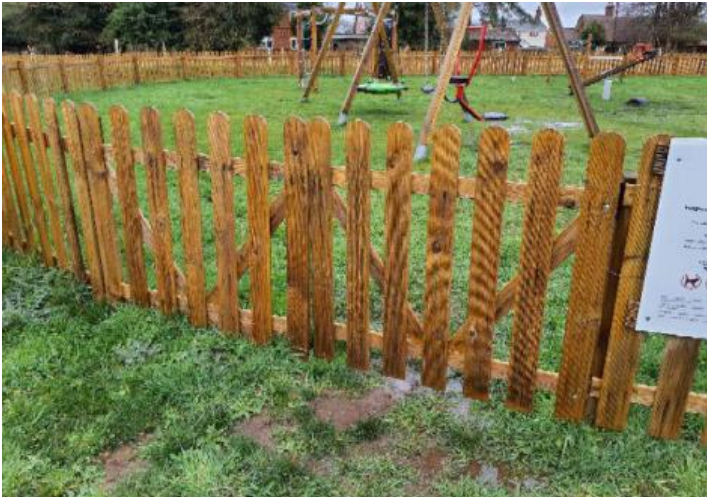
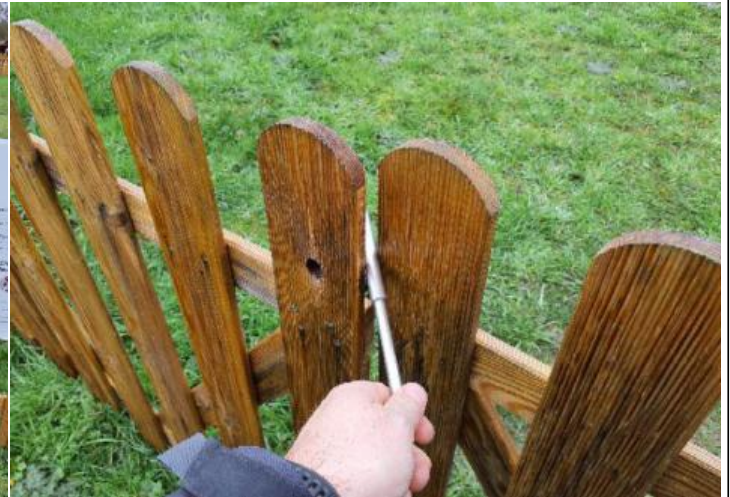
**Item:** Gates - Gate - Combination  
**Manufacturer:** Not Identified

**Finding:** There are openings that are less than 12mm that could trap or crush fingers

**Action:** Provide a 12mm gap throughout full range of motion at both sides of gate

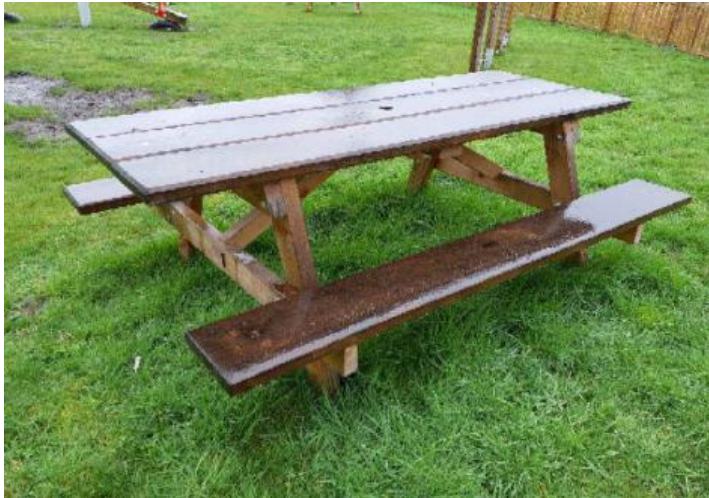
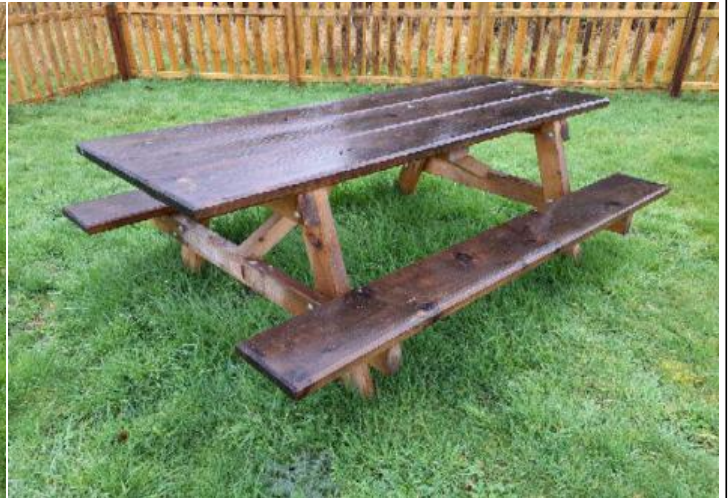
**Item:** Ancillary Items - Picnic Table  
**Manufacturer:** Not Identified

**Finding:** The table/s is/are not secured to the ground and there is some potential for the item/s to be moved within falling spaces of equipment

**Action:** Secure to the ground

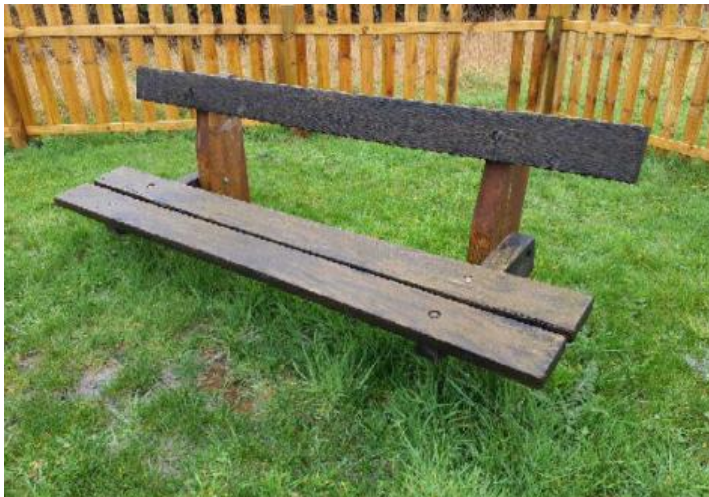
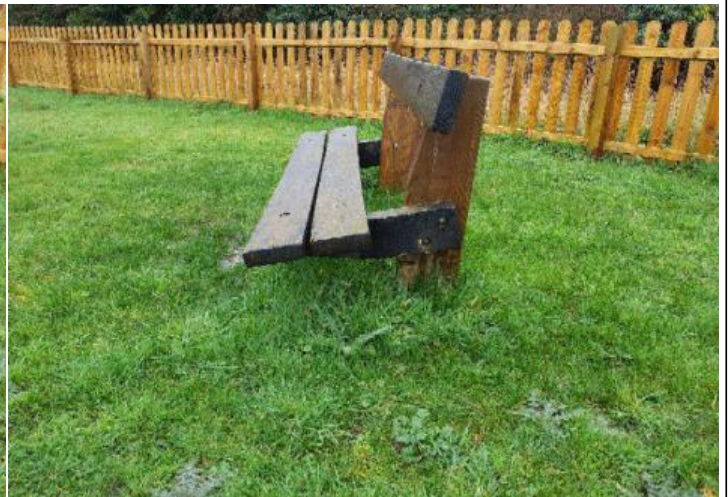
**Item:** Ancillary Items - Bench  
**Manufacturer:** Not Identified

**Finding:** The seat slats are slanted downward

**Action:** Adjust if required

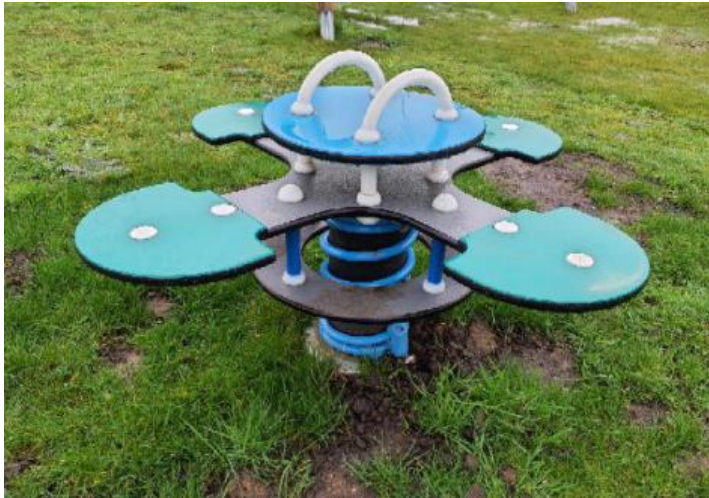
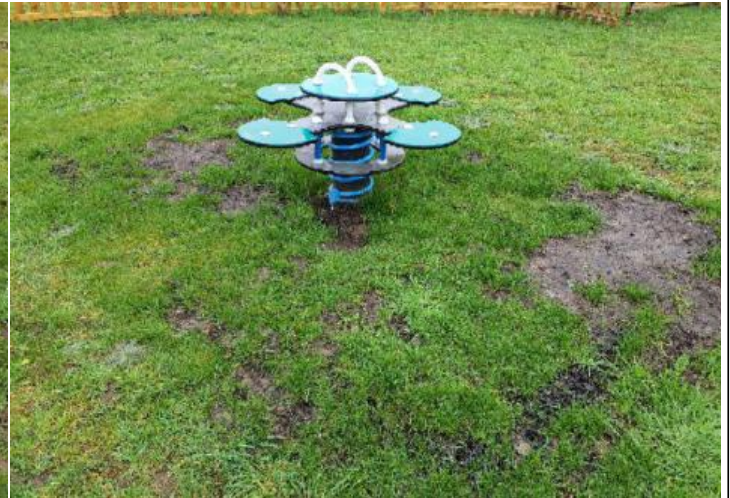
**Item:** Rocking Equipment - Four Way Springer  
**Manufacturer:** Kompan Ltd

**Finding:** The grass mats are silted up, the soil is compacted and the area will become very slippery when the soil is wet. **Action:** Reinstate as required

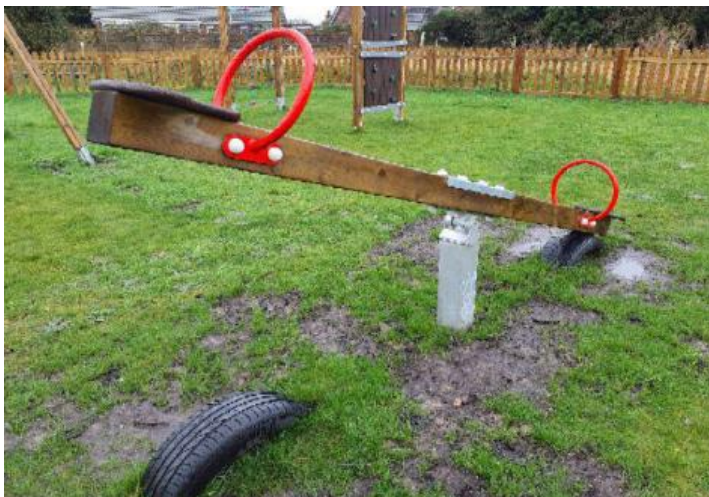
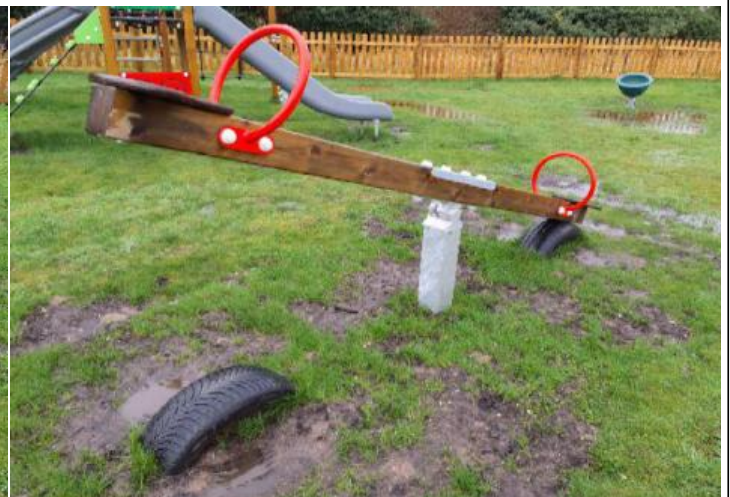
**Item:** Rocking Equipment - See Saw  
**Manufacturer:** Kompan Ltd

**Finding:** The grass mats are silted up, the soil is compacted and the area will become very slippery when the soil is wet. **Action:** Reinstate as required

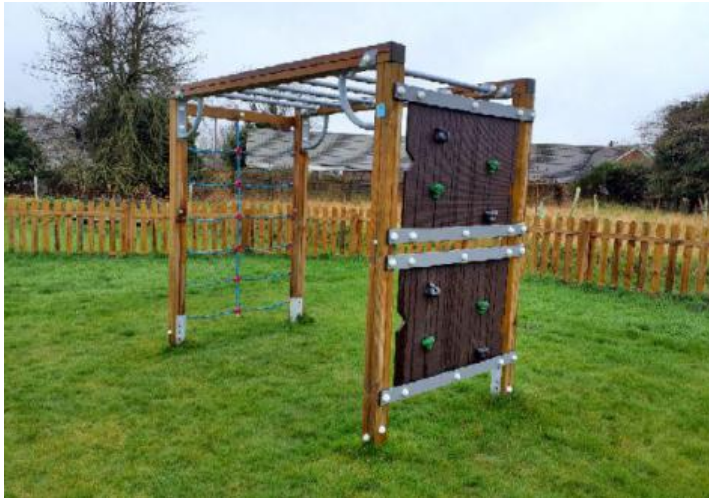
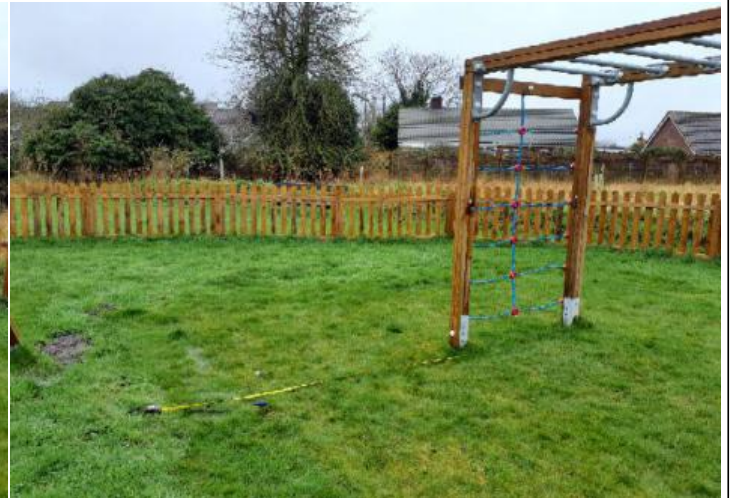
**Item:** Activity Equipment - Climbing Frame  
**Manufacturer:** Kompan Ltd

**Finding:** The surfacing dimensions are short and do not meet with the requirements of the current applicable standard (1.94m required / 1.40m provided)

**Action:** Extend surface area to comply

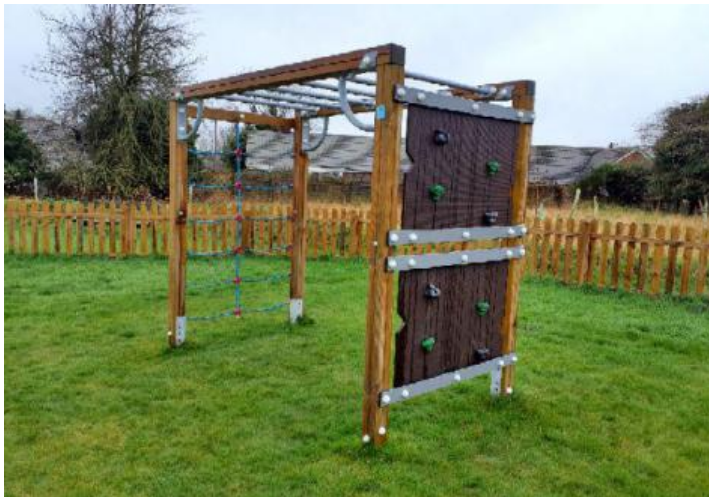
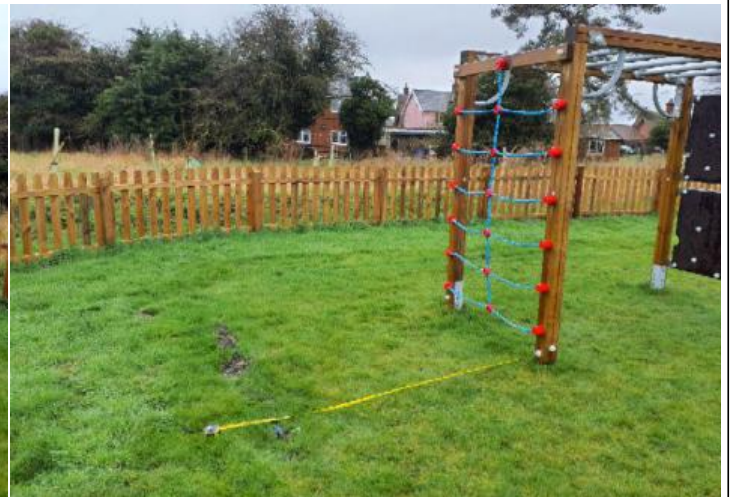
**Item:** Activity Equipment - Climbing Frame  
**Manufacturer:** Kompan Ltd

**Finding:** The surfacing dimensions are short and do not meet with the requirements of the current applicable standard (1.94m required / 1.70m provided)

**Action:** Extend surface area to comply

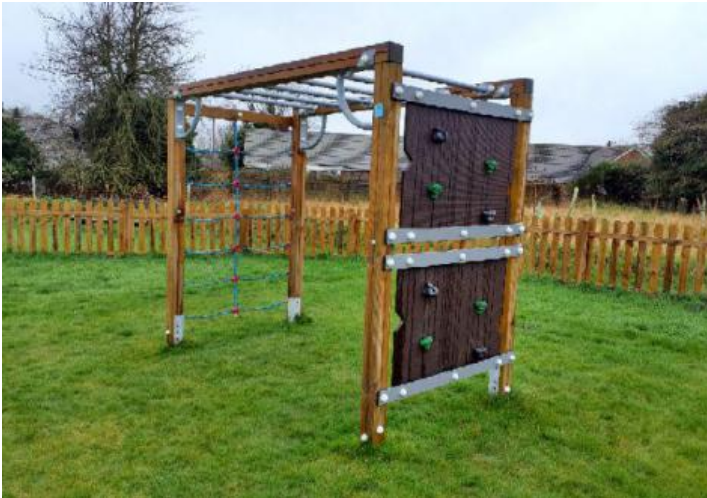
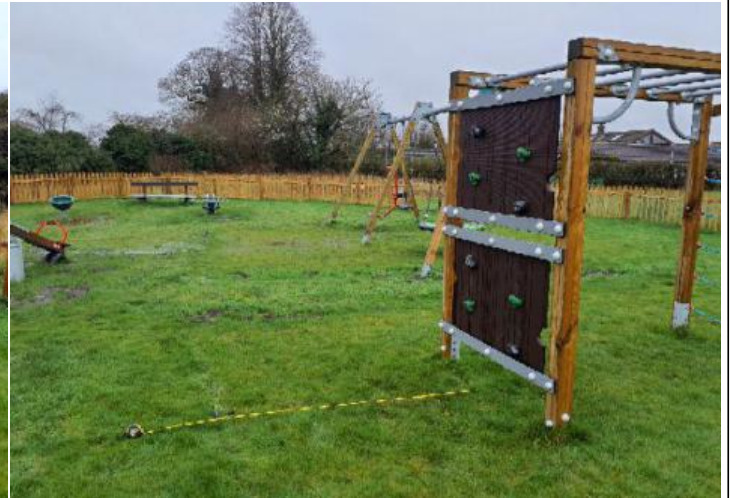
**Item:** Activity Equipment - Climbing Frame  
**Manufacturer:** Kompan Ltd

**Finding:** The surfacing dimensions are short and do not meet with the requirements of the current applicable standard (1.94m required / 1.60m provided)

**Action:** Extend surface area to comply

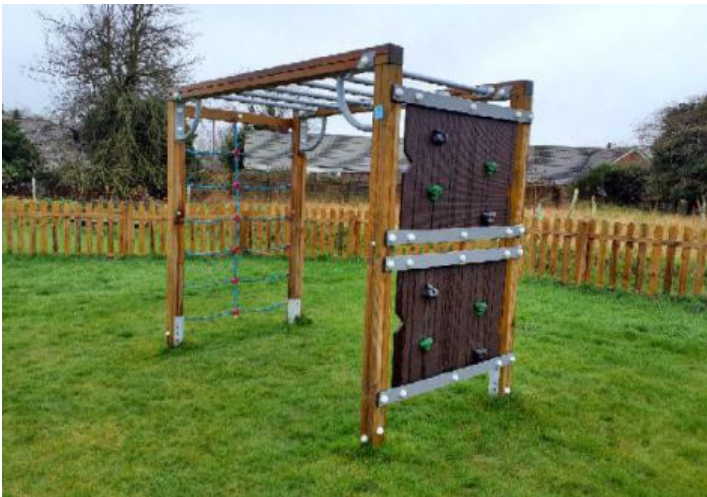
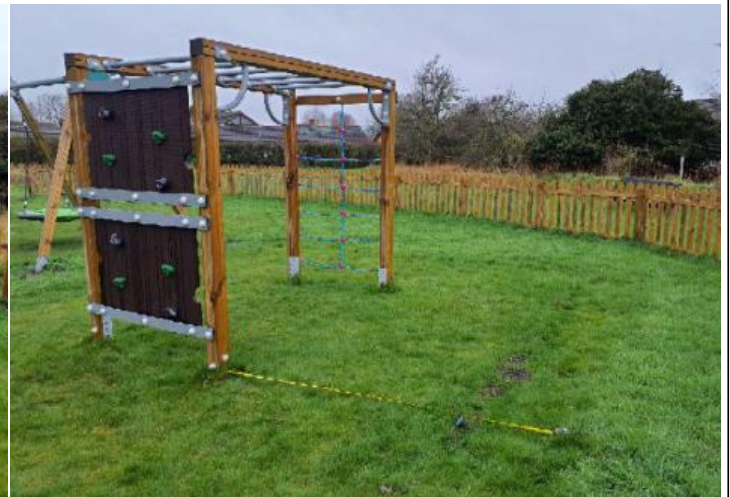
**Item:** Activity Equipment - Climbing Frame  
**Manufacturer:** Kompan Ltd

**Finding:** The surfacing dimensions are short and do not meet with the requirements of the current applicable standard (1.50m required / 1.94m provided)

**Action:** Extend surface area to comply

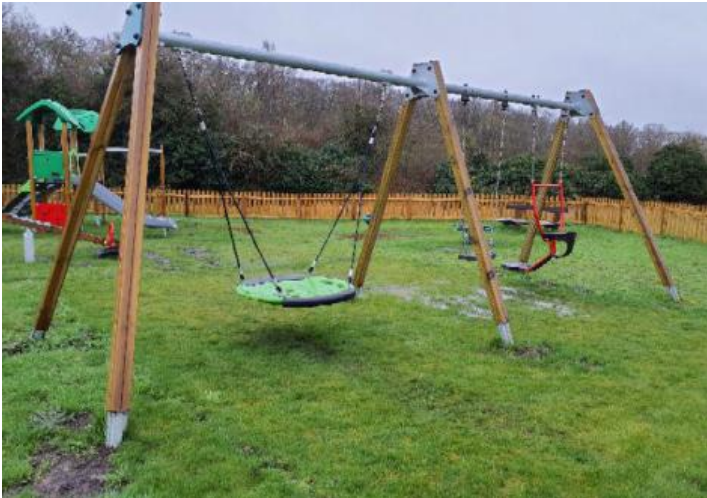
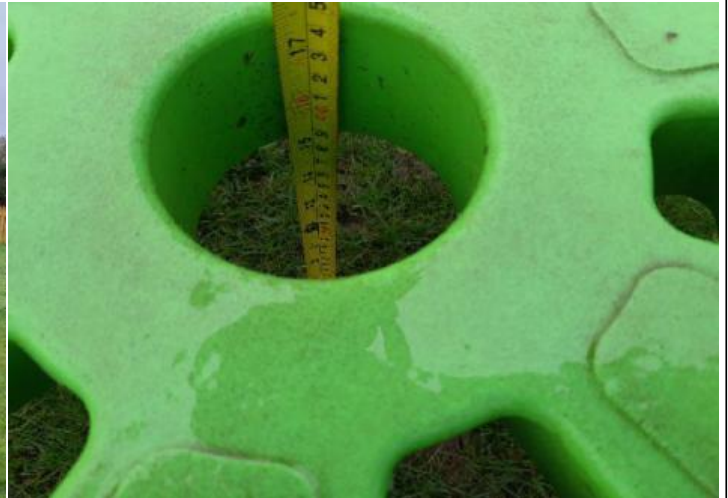
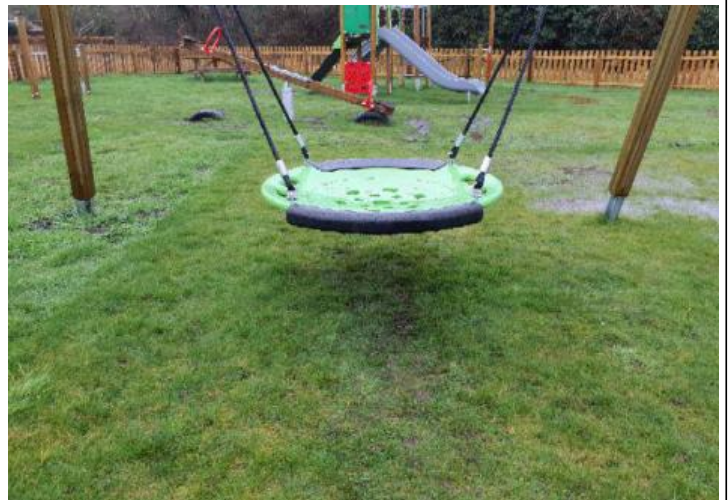
**Item:** Swings - 2 Bay Swing  
**Manufacturer:** Kompan Ltd

**Finding:** The seat clearance from finished surface level to the underside of the seat is too low and does not meet the requirements of BS EN 1176 Part 2 (400mm minimum clearance required from rigid part of seat in most onerous position)

**Action:** Adjust seat clearance

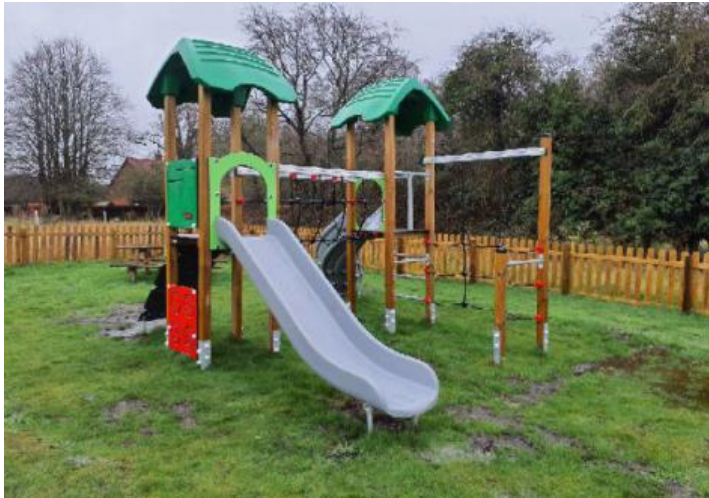
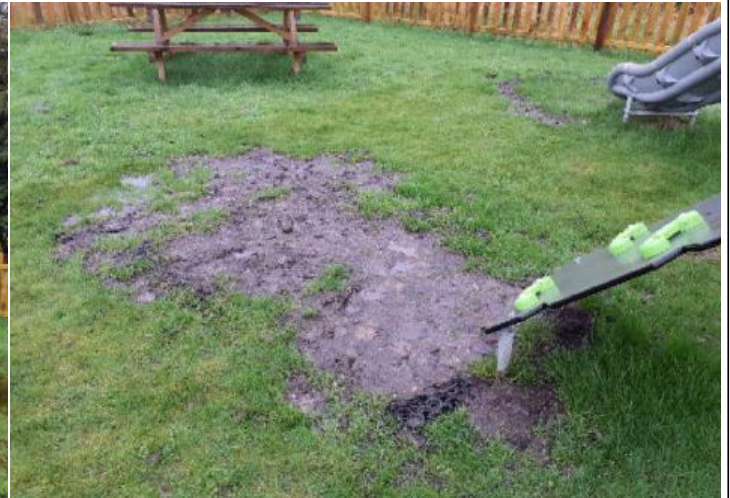
**Item:** Activity Equipment - Multi Play (Junior)  
**Manufacturer:** Kompan Ltd

**Finding:** The grass mats are silted up, the soil is compacted and the area will become very slippery when the soil is wet. **Action:** Reinstate as required

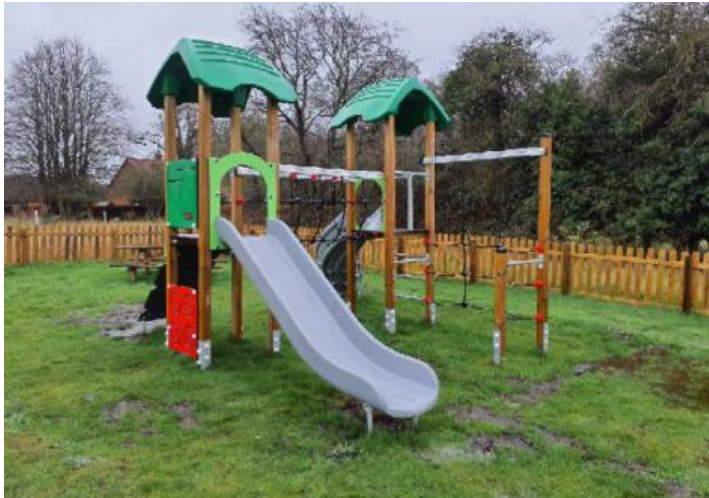
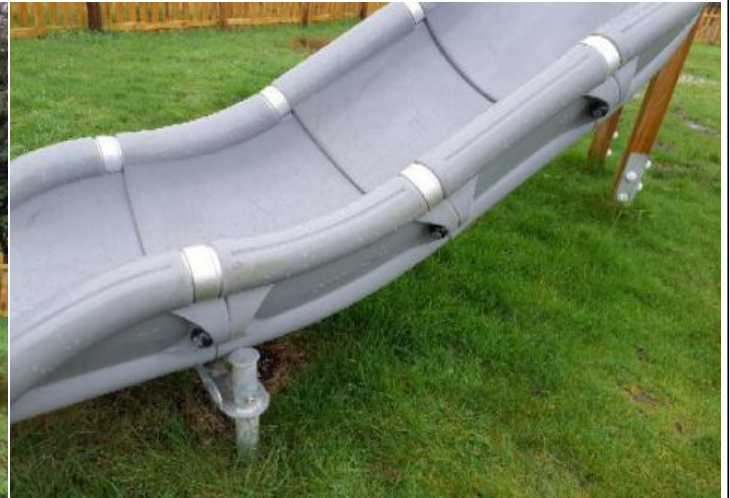
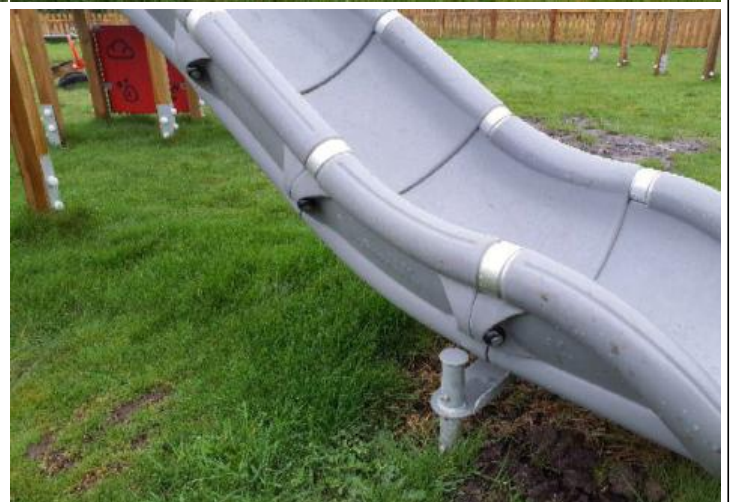
**Item:** Activity Equipment - Multi Play (Junior)  
**Manufacturer:** Kompan Ltd

**Finding:** There is/are bolt cap covers missing or damaged on the item

**Action:** Replace missing or damaged bolt cap covers
