PLAY AREA SAFETY (ANNUAL) INSPECTION REPORT

For Redgrave Parish Council

On 10th September 2025

Play Area, Half Moon Lane, Redgrave

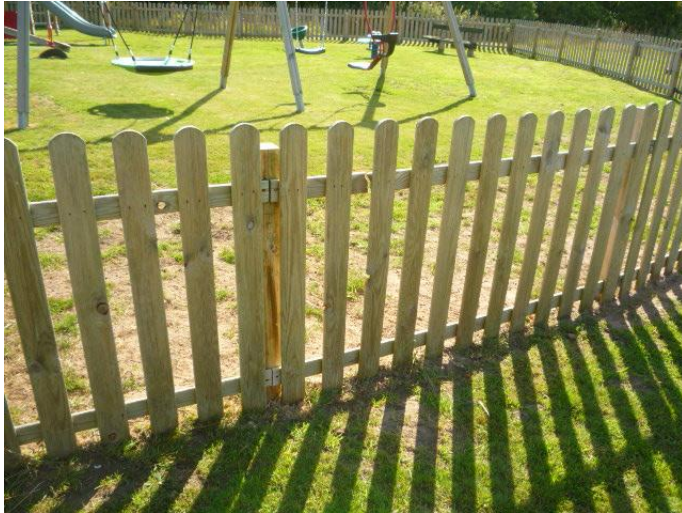
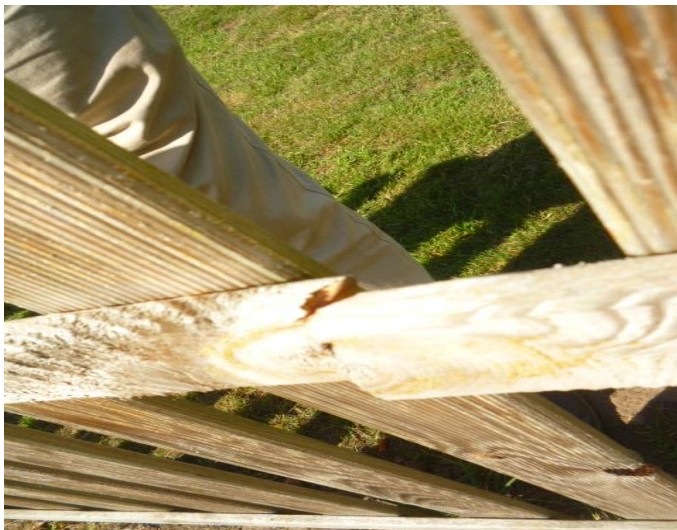
Timber Picket Fence (1000mm) – Recommend repair/replace damaged slat - Low risk.

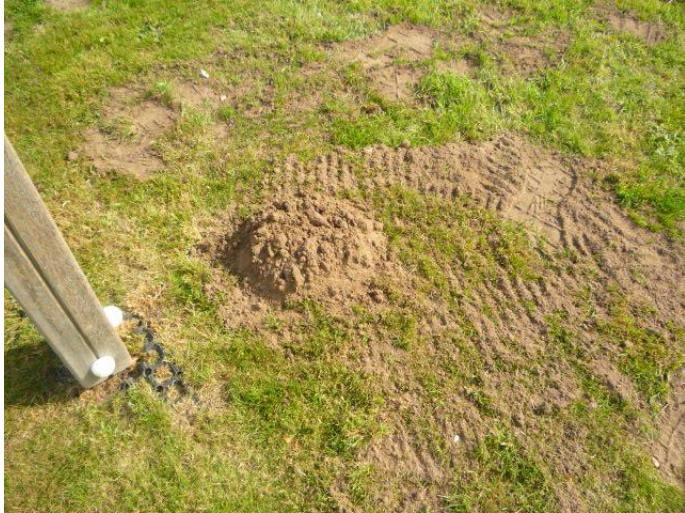
General surface - Grass - Molehills form trip hazards - Recommend to remove moles or level off molehills when found to eliminate trip hazards - Low risk.

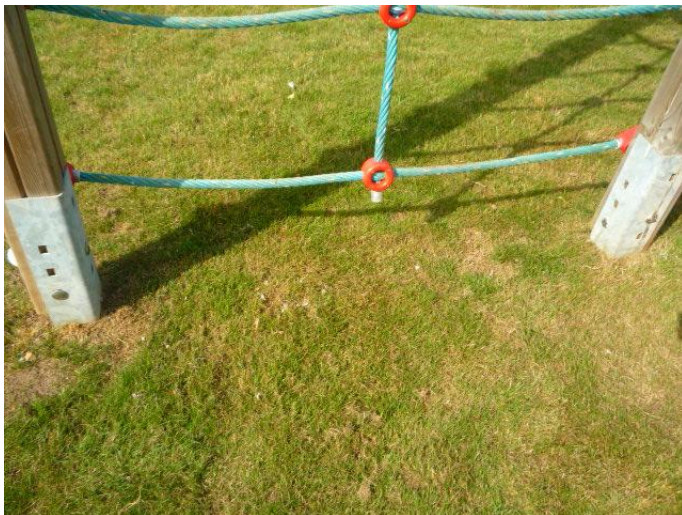
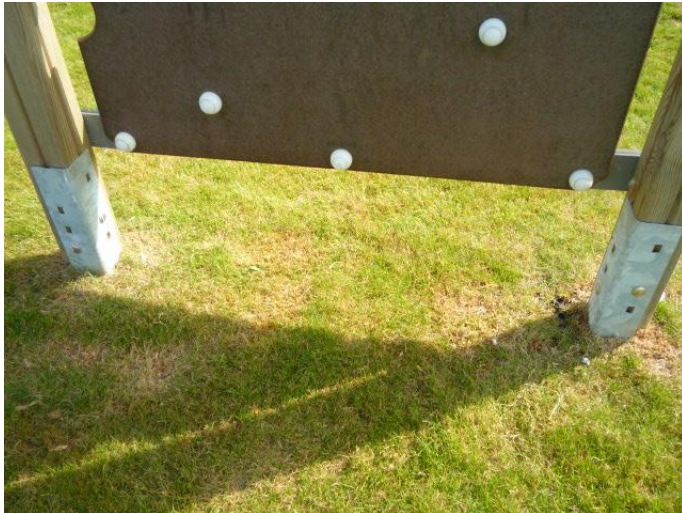
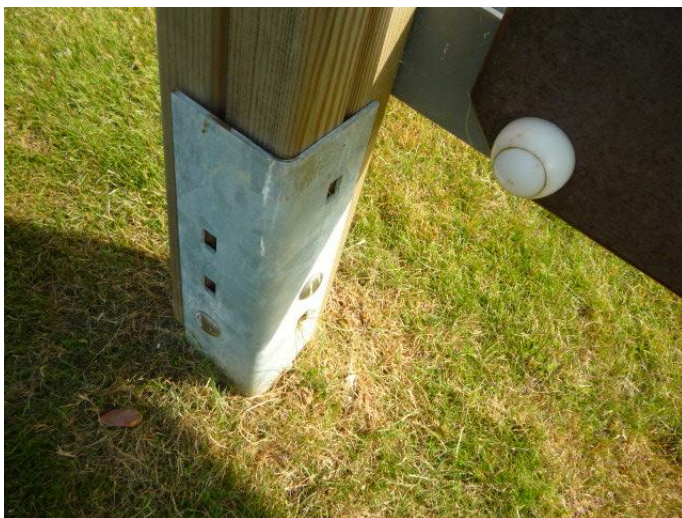
Item: Overhead Ladder - Kompan

The item fails to meet the requirements of EN1176 in the following respects:

Unstable – Recommend add more bolts to all four supports to stabilise item - Low to medium Risk.

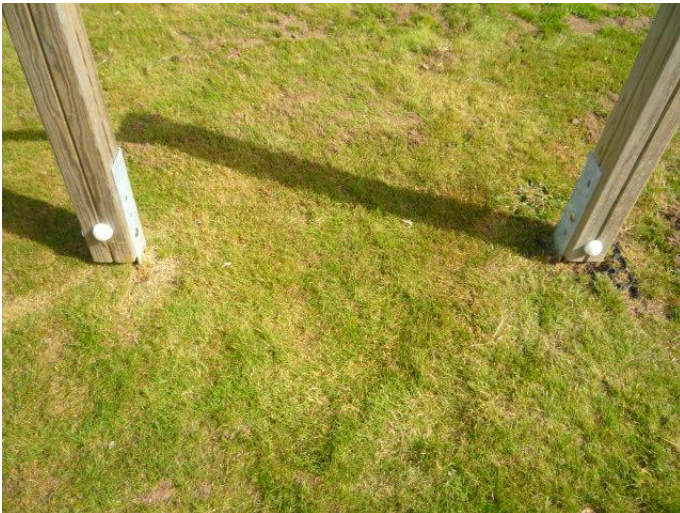
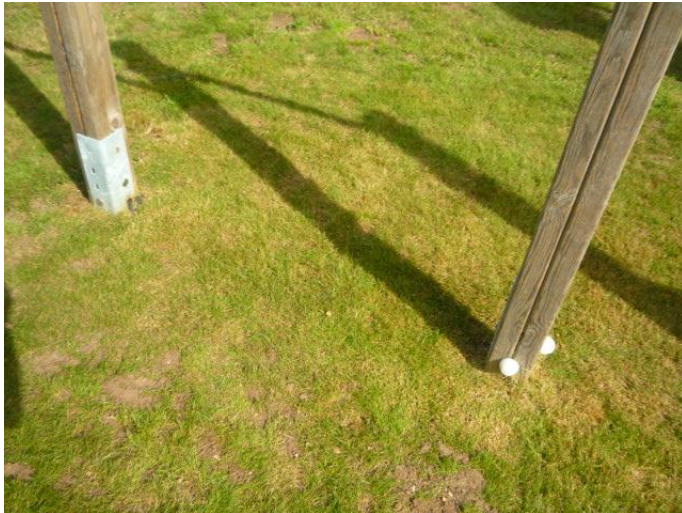
Item: Pull Up Bars - Kompan

The item fails to meet the requirements of EN1176 in the following respects:

Unstable – Recommend add more bolts to all four supports to stabilise item - Low to medium Risk.

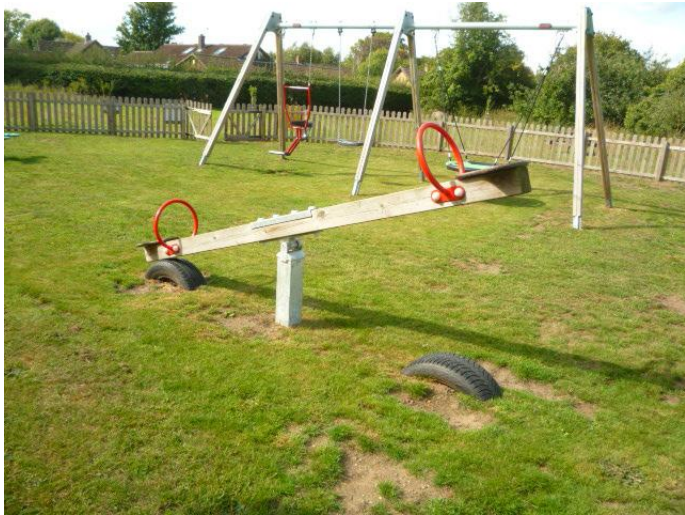
This type of safety surface should have grass present to provide adequate protection in user falls, as the grass roots absorb the impact of any falls. The surface therefore does not give the same protection as with grass and the risk of damage to users in falls is increased.

In the first instance it is recommended to (when conditions allow) add turf over the worn areas – Low risk.

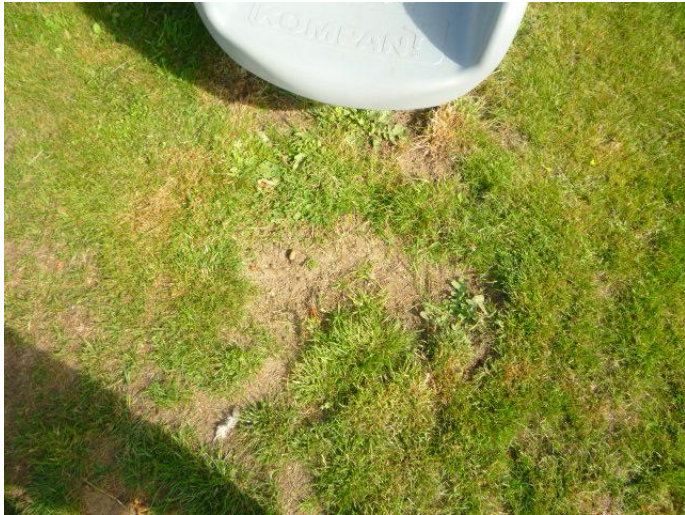
This type of safety surface should have grass present to provide adequate protection in user falls, as the grass roots absorb the impact of any falls. The surface therefore does not give the same protection as with grass and the risk of damage to users in falls is increased.

In the first instance it is recommended to (when conditions allow) add turf over the worn areas – Low risk.
